FINAL REPORT

Occurrence No: 801/14

**a) Embraer, EMB-505 Phenom 300,
registration marks: D-CRCR**

**b) Boeing 737-800,
registration marks: SP-ENY**

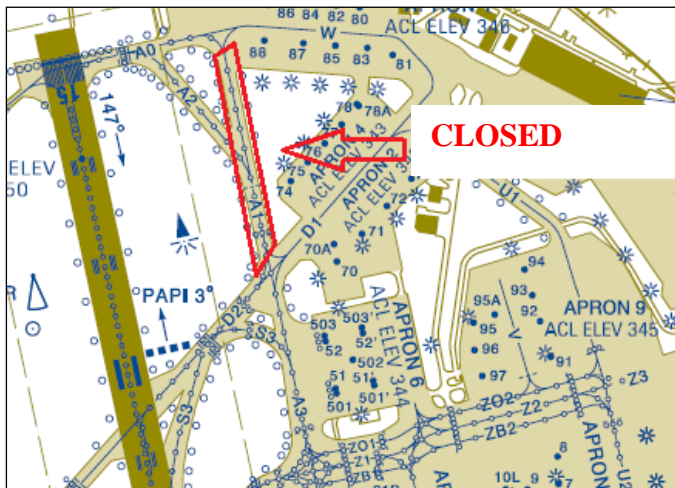
Extract from AIP Poland (closed TWY A1 marked)

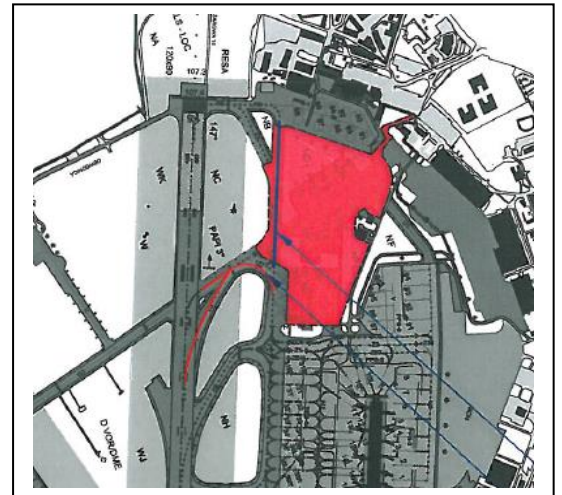
Extract from EPWA documentation (closed surfaces of the aerodrome marked).

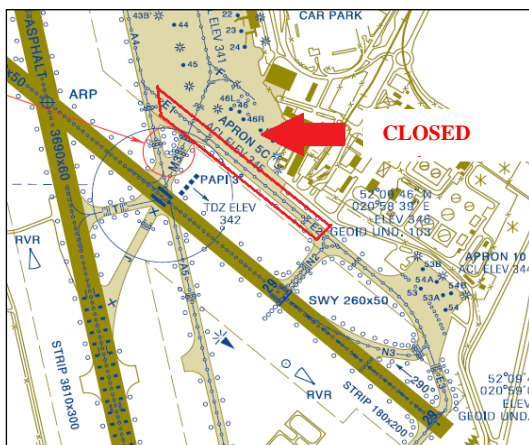
Extract from AIP Poland (closed TWY E marked).

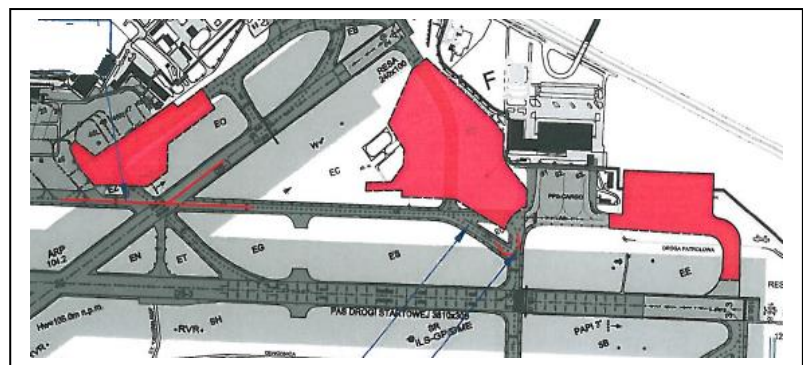
Extract from EPWA documentation (closed surfaces marked).

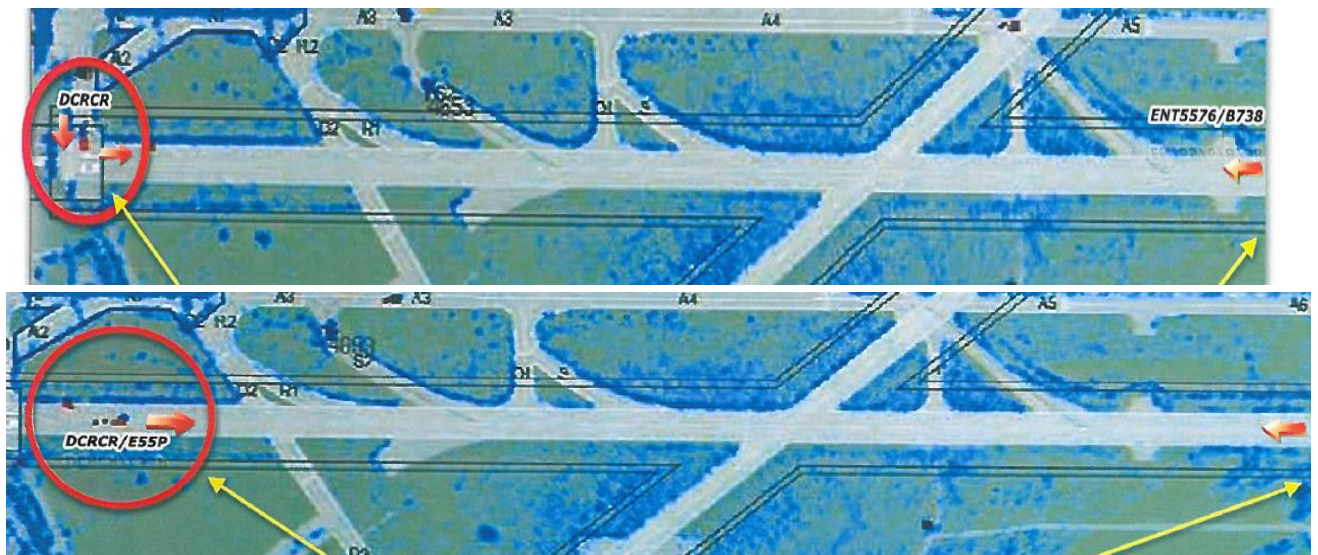
Time: 12:44:08 hrs – the airport radar recording shows DCRCR airplane in the course of entering RWY15/33 from RWY 15 threshold via TWYA0 and taxiing towards RWY33 threshold (radar screen shots below);

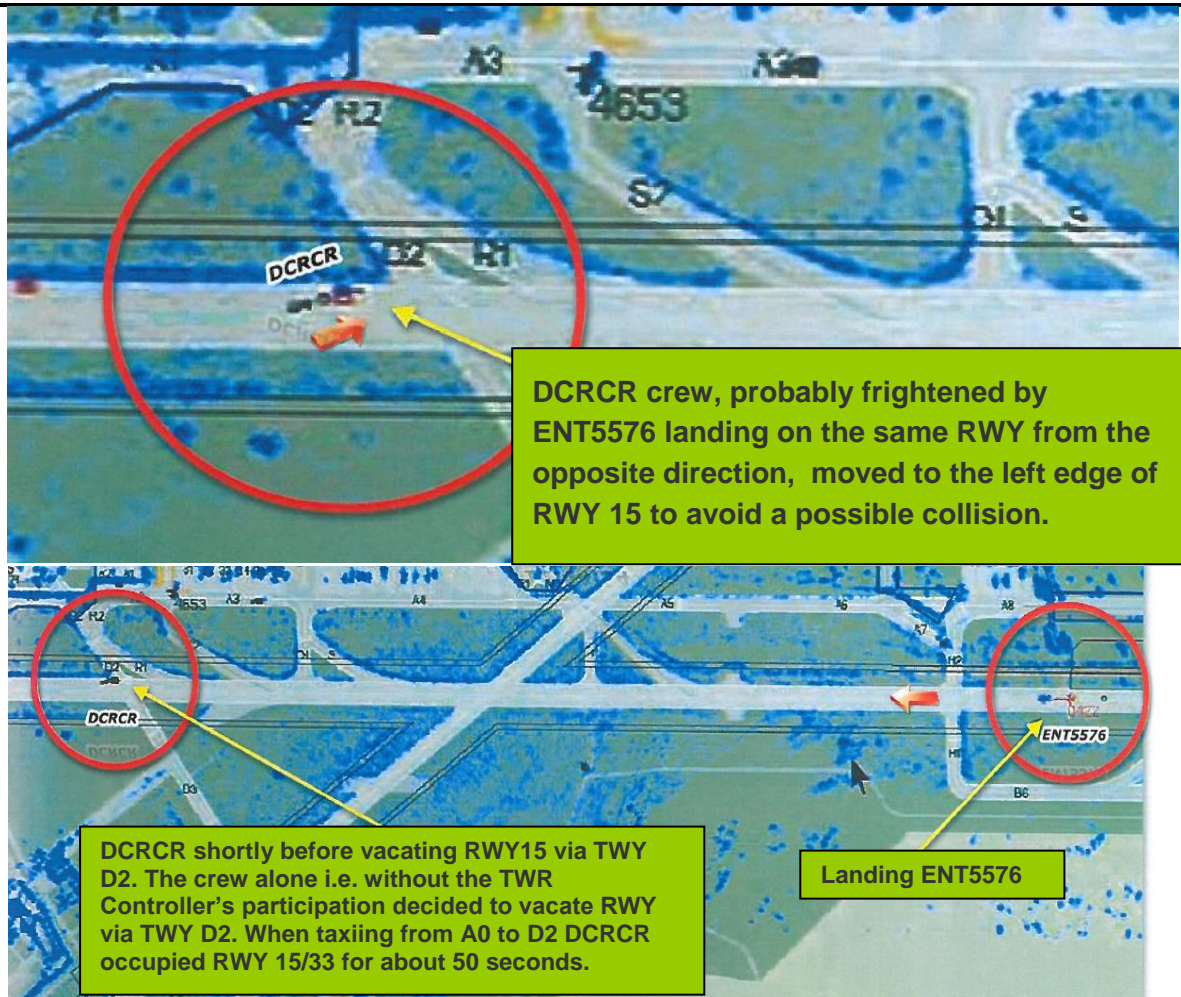
Time: 12:44:53 hrs - ENT5576 landed. At this moment DCRCR reached TWY D2 and vacated RWY via this taxiway.

An important element of the incident was the Controller's failure to notice DCRCR taxiing on RWY 15/33 for about 50 seconds. The airplane created the risk of collision with ENT5576 landing on RWY 33.

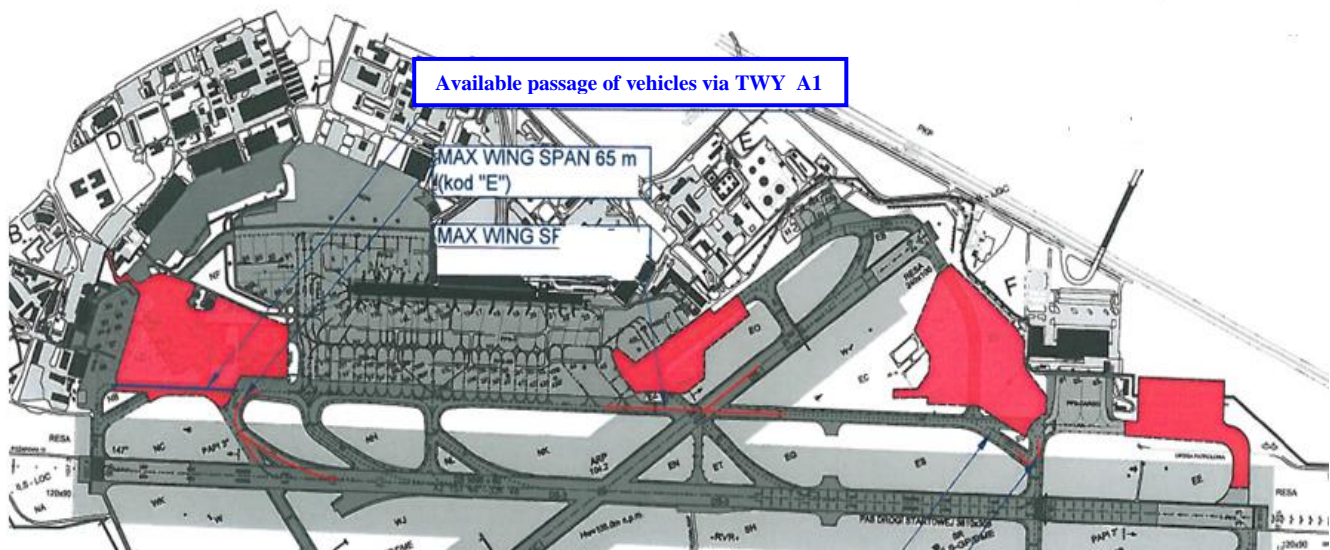
Active RWYs 11/29 and 15/33 were used by the airplanes taxiing for takeoff. It was necessary due to the closure of TWY A1, E1 and E2 up to TWY N.

An important factor affecting the occurrence of the incident was the failure to impose some restrictions on the number of aviation operations due to the fact that TWYs and aerodrome surfaces important for the ground movement were closed.
