**STATE COMMISSION ON AIRCRAFT ACCIDENTS  
INVESTIGATION**

**FINAL REPORT**

**Occurrence No: 1949/14**

**Aircraft: BB-42 Z Kubiček balloon, SP-BDF**

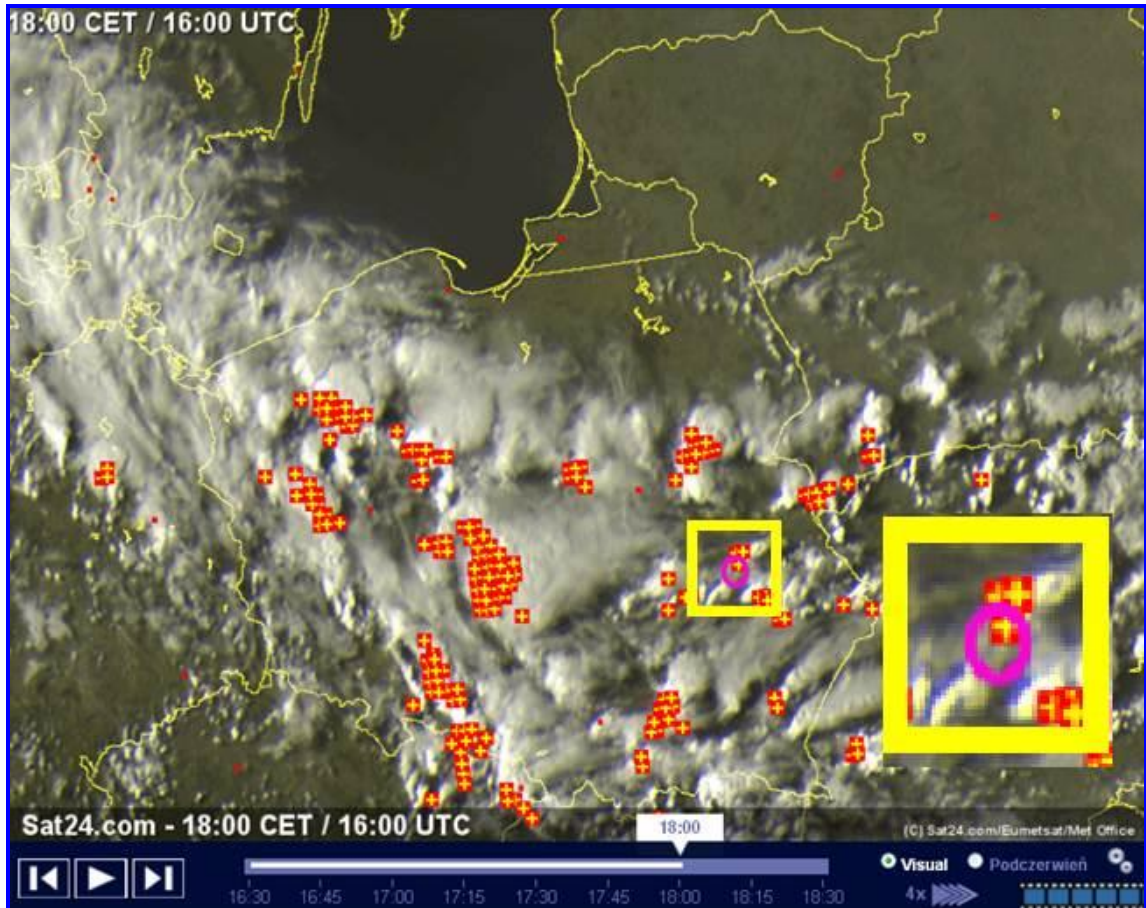
Satellite image of cloud cover at 16:00 hrs UTC on 23 April 2014.

The satellite images clearly show that at the takeoff place, along the balloon's flight route and over the occurrence site at the occurrence time the cloud cover was 8/8 due to the *Cumulonimbus calvus* cloud moving along the route of the balloon.

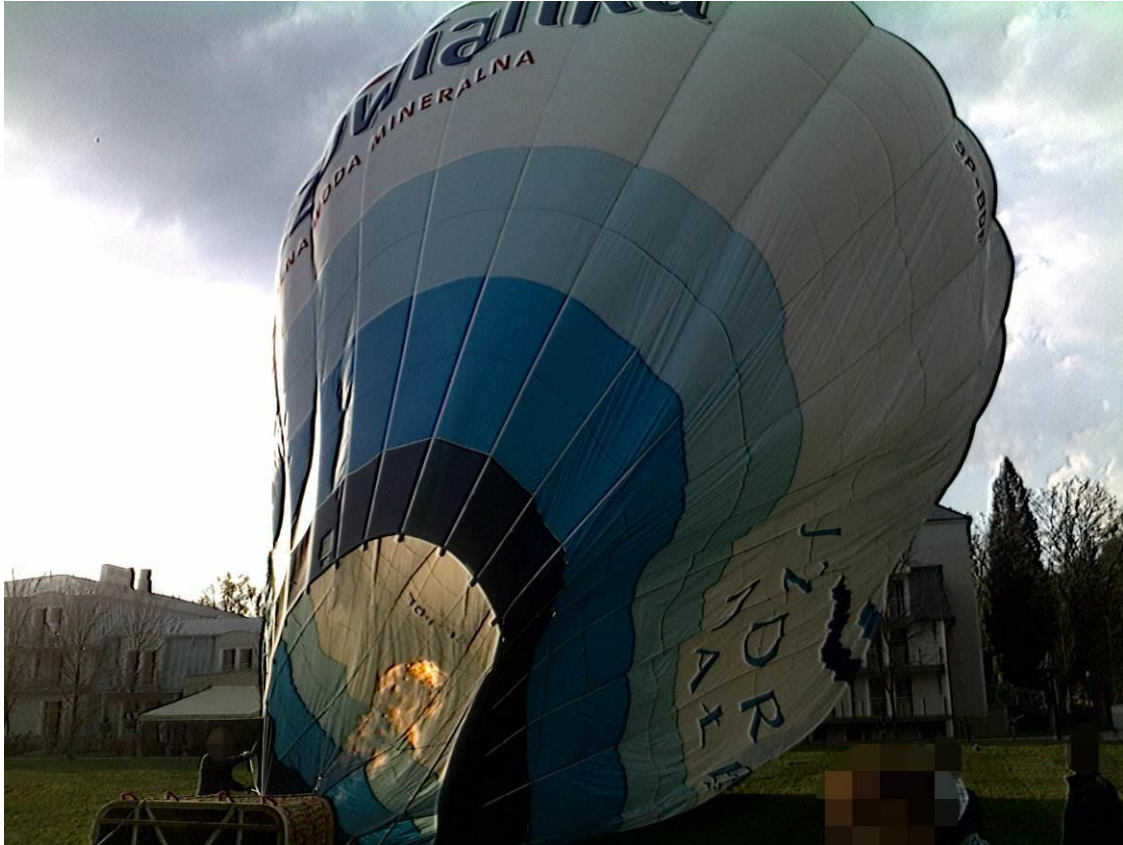
*Photo No 1 made during inflation of the balloon. Behind the balloon puffy clouds moderately developed vertically with dark bases visible, and in background on the left side of the balloon stratus opacus cloud visible. Source: passenger of the balloon.*

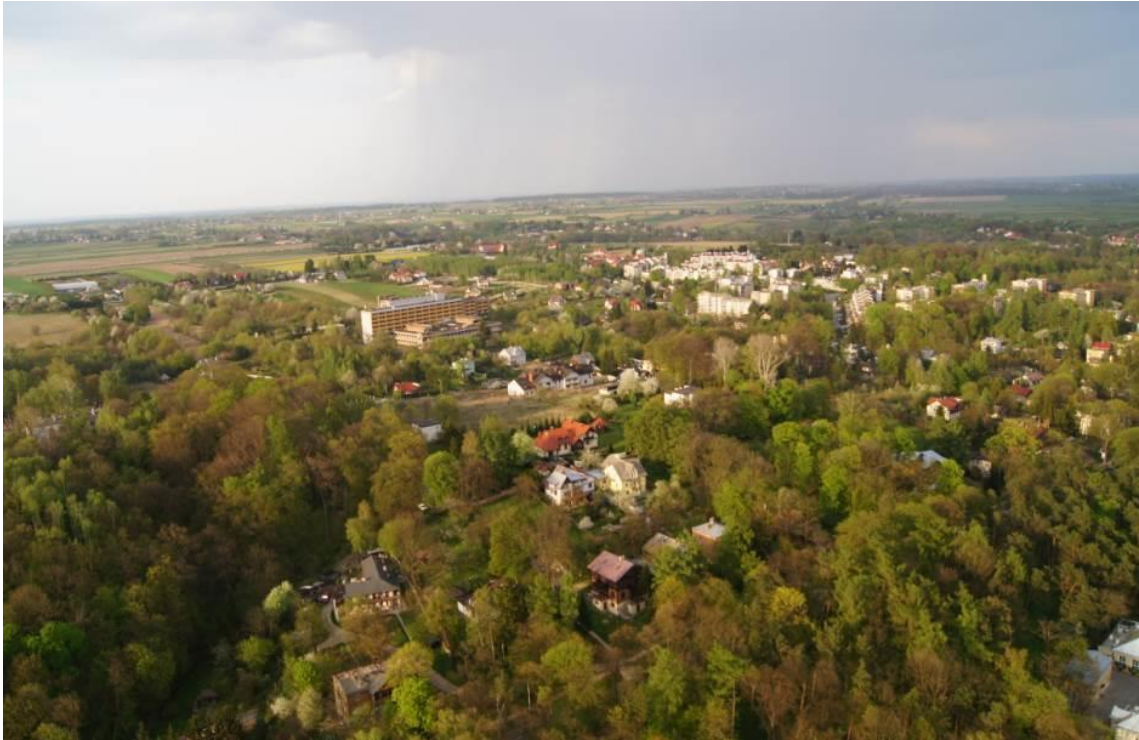
*Photo No 2 made during the balloon flight shortly after takeoff. A cloud with dark basis visible and beneath it streaks of rain. In the background on the right a portion of the illuminated puffy cloud, and on the left side stratus opacus cloud visible. Source: passenger of the balloon.*

The pilot claimed that weather conditions deteriorated about 40 - 50 minutes after the takeoff. However, the analysis of timing of photos taken by the passengers proves that the CB cloud and rain were visible from the balloon just one minute after takeoff. In the Commission's opinion, the pilot should have recognized the visible threat and to immediately land at the first possible place. The analysis of the photos taken by the passengers shows that the balloon was flying over arable lands, on which a safe landing could have been performed. The Commission notes that in an emergency situation inflicting losses on arable lands or difficulties connected with carrying a balloon components to the nearest road suitable for a car are meaningless. The most important is safety, but possible losses of course should be compensated.

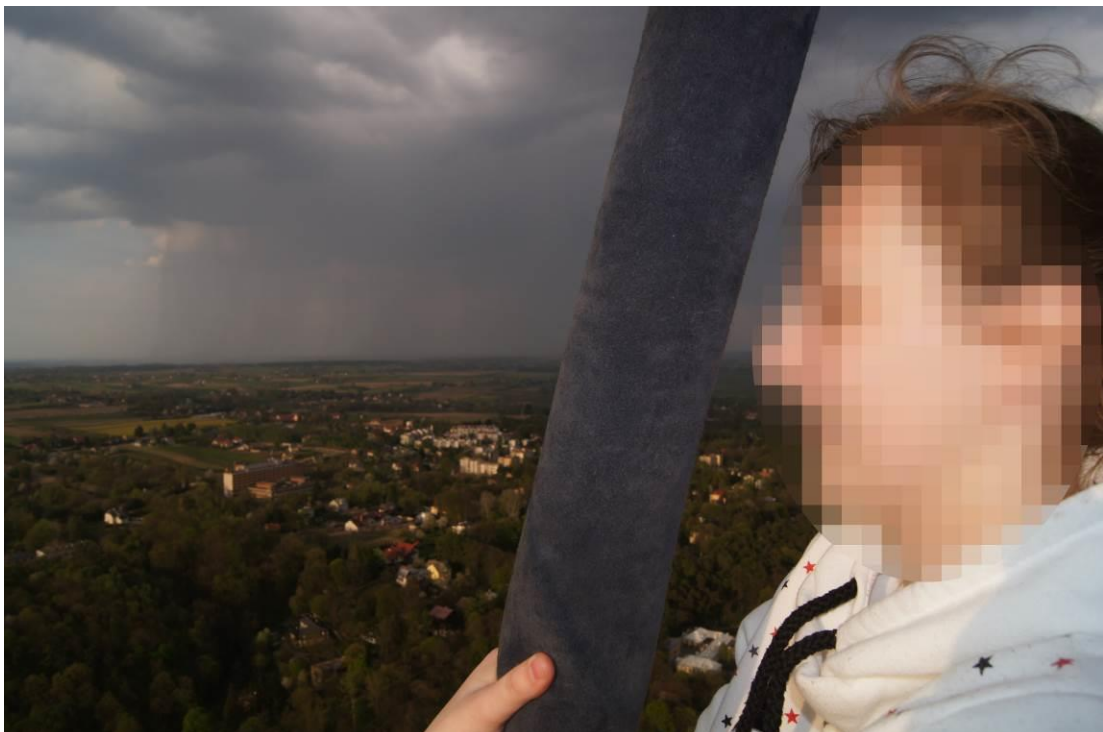
*Photo No 3 made during the balloon flight. A cloud with dark corrugated base and beneath streaks of rain visible. Source: passenger of the balloon.*

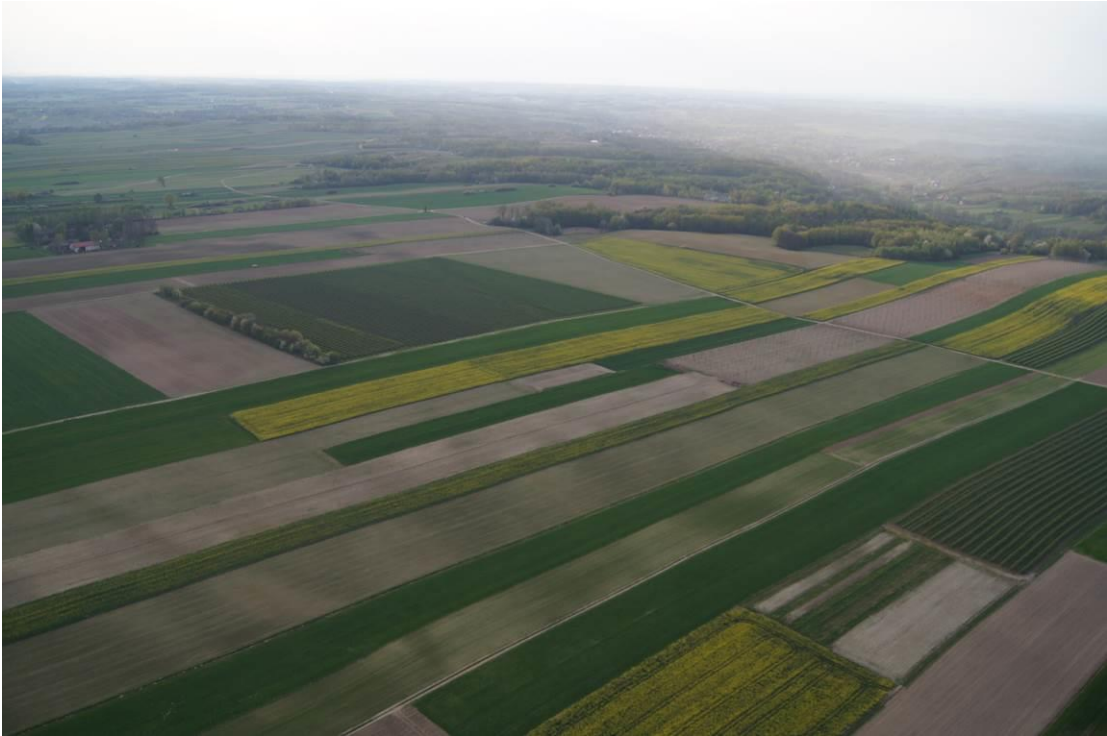
*Photo No 4 made during the balloon flight. In the background on the right side the so-called “dust storm” visible. “Dust storm” is dust picked up from the ground by strong wind accompanying Cumulonimbus cloud. Source: passenger of the balloon.*

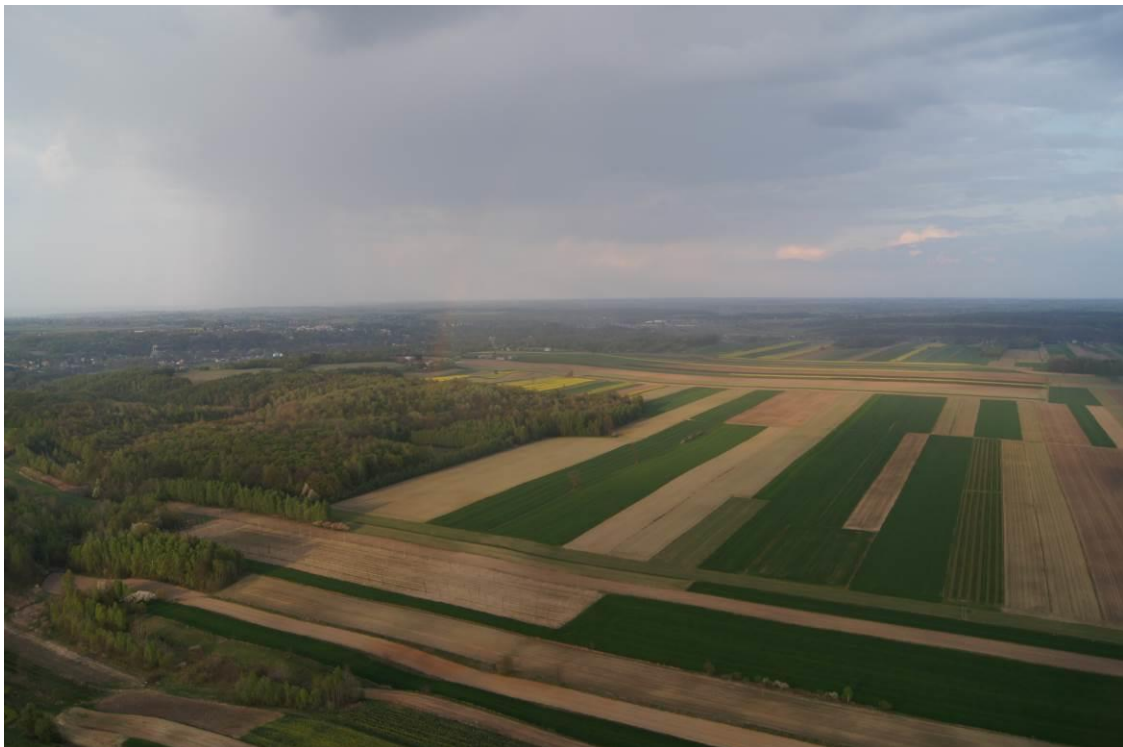
*Photo No 5 taken during the balloon flight. Dark cloud base visible, and streaks of rain and a portion of the rainbow beneath. The rainbow is visible from a location between the sun and raindrops. In the background, on the right side illuminated puffy clouds vertically developed visible. Source: passenger of the balloon.*
