FINAL
KNKT.14.12.29.04

Aircraft Accident Investigation Report

PT. Indonesia Air Asia
Airbus A320-216; PK-AXC
Karimata Strait
Coordinate 3°37'19"S - 109°42'41"E
Republic of Indonesia
28 December 2014

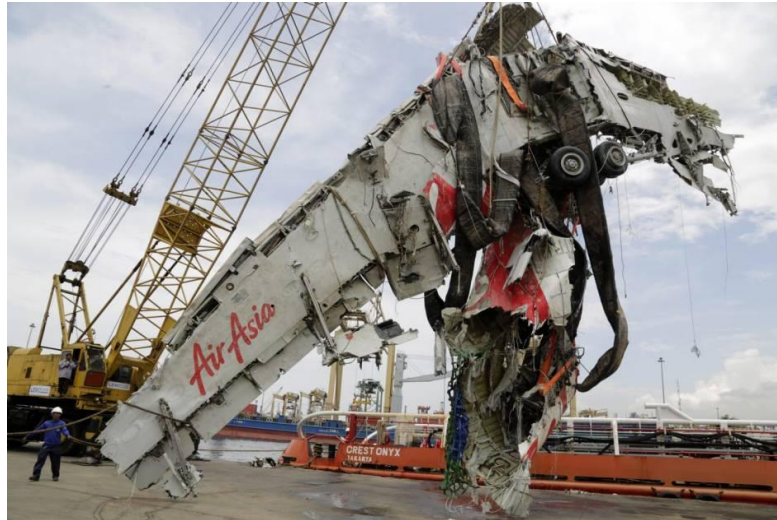
Figure 5: Centre fuselage section including the wings and main landing gears

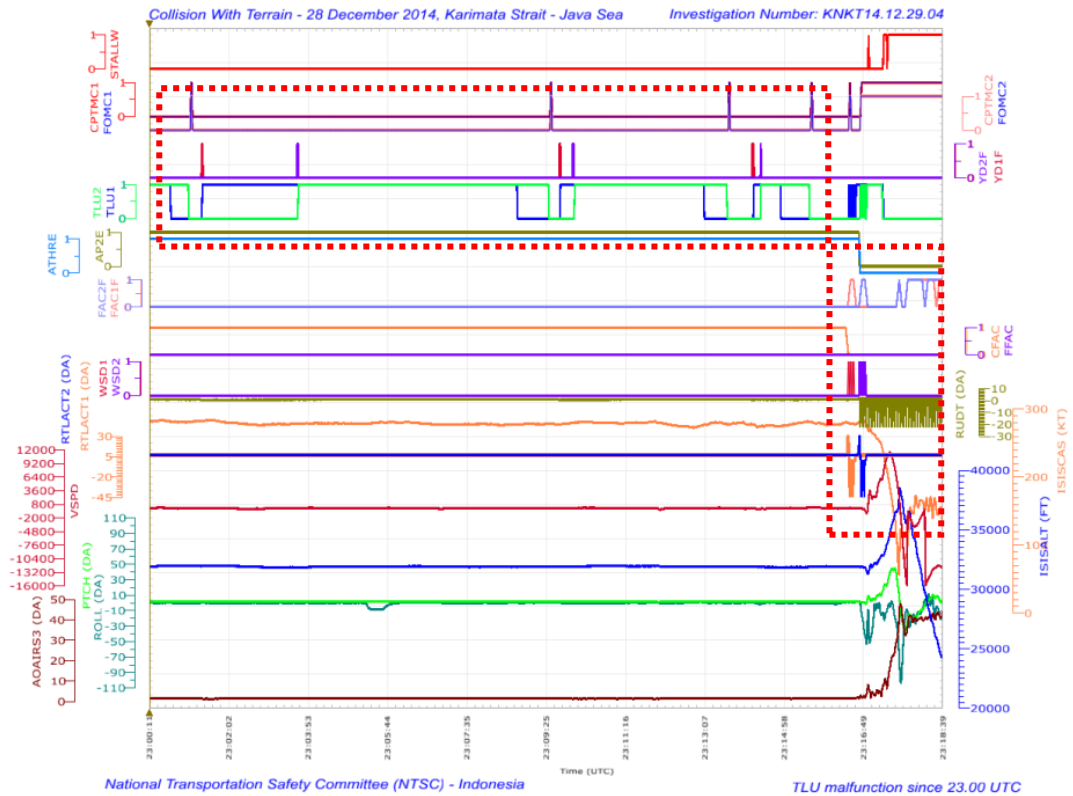
Figure 20: RTLU problems and pilot actions

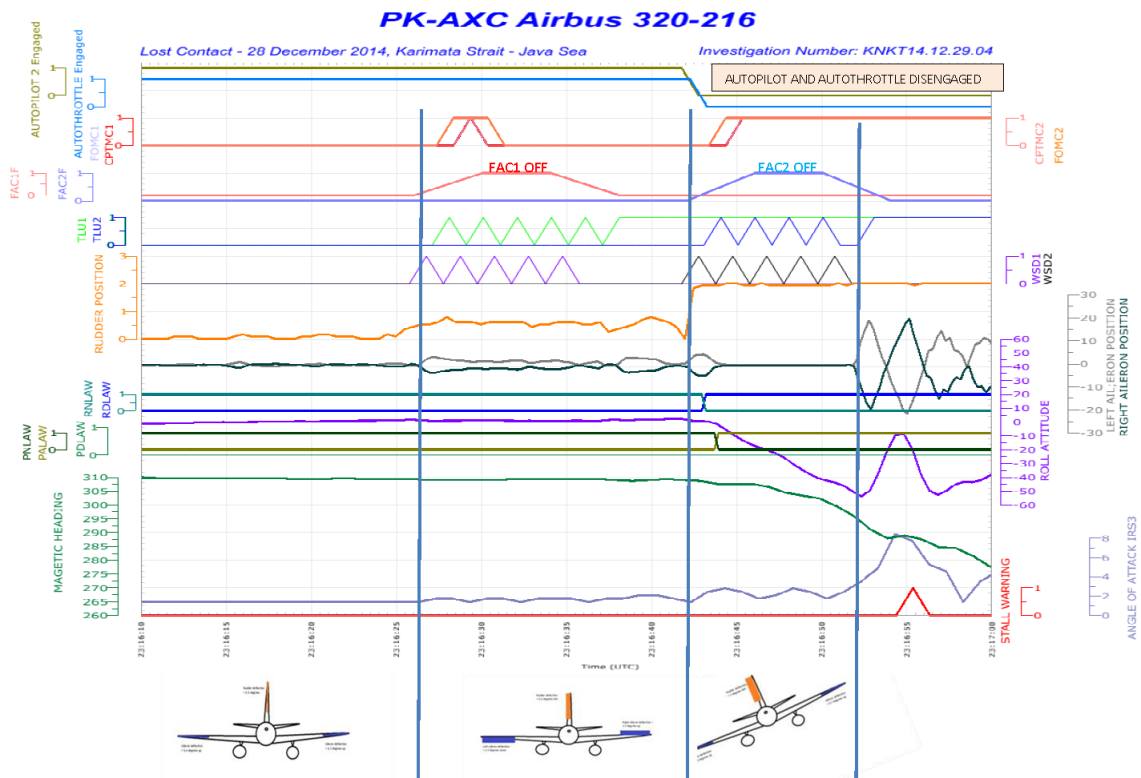
The fifth Master Caution at 2316:28 UTC was triggered by FAC 1 FAULT.

Figure 21: FDR parameters after the fifth Master Caution

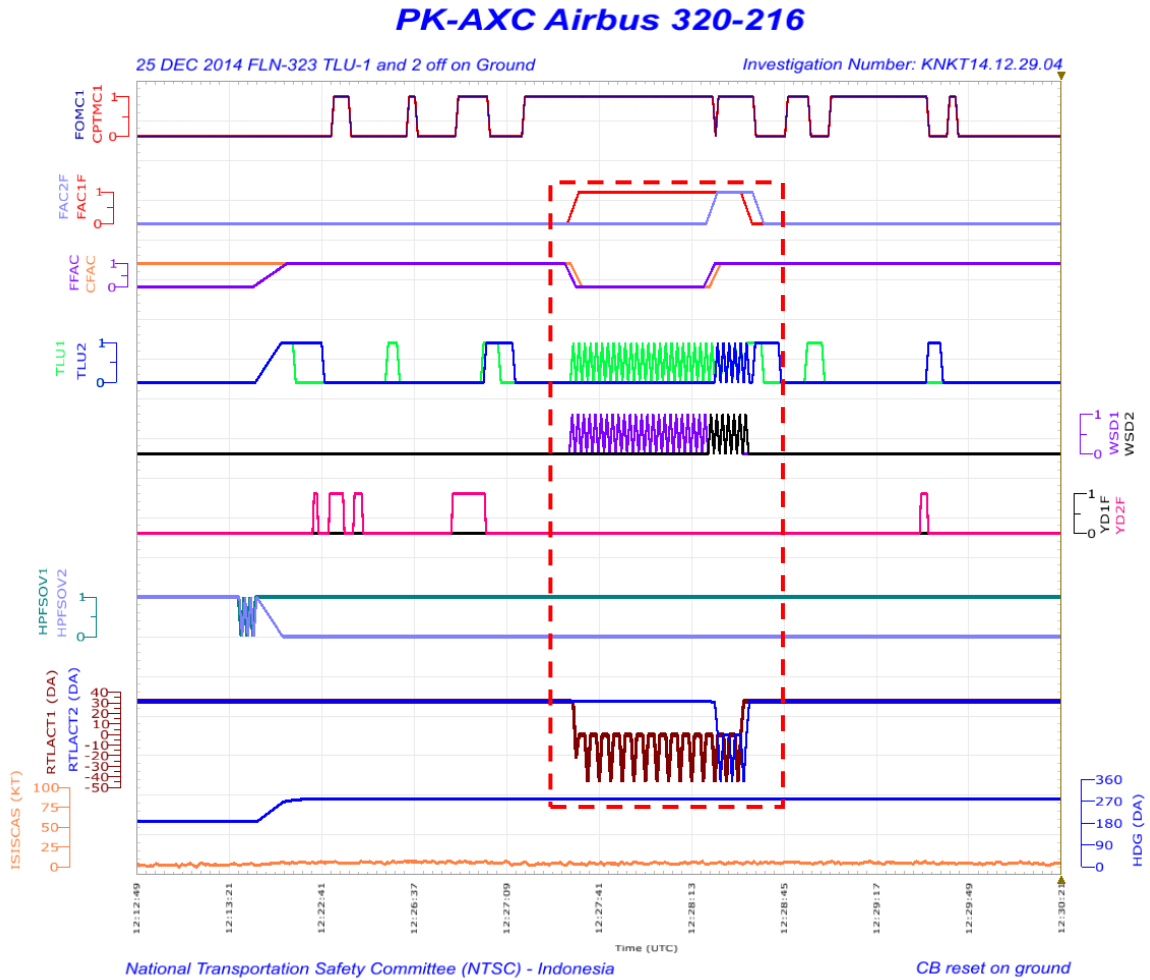
Figure 24: The FDR parameters of FAC fault followed by CB reset on the ground at 25 December 2014

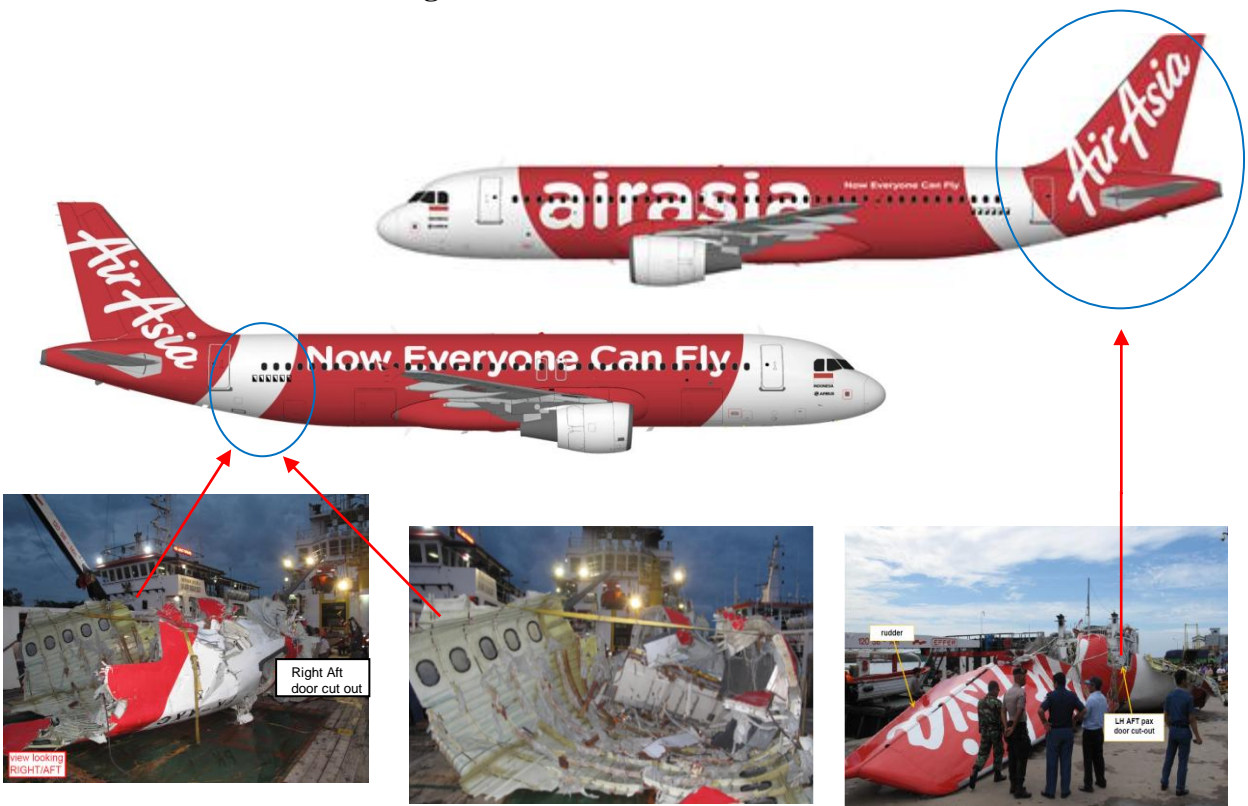
Figure 32: Pictures of identified parts and its original position

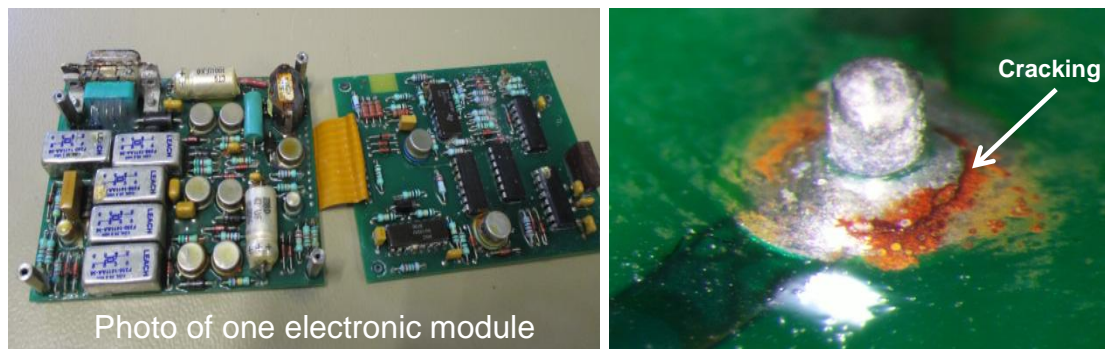
- The cracking of a solder joint of both channel A and B resulted in loss of electrical continuity and led to RTLU failure.
- The existing maintenance data analysis led to unresolved repetitive faults occurring with shorter intervals. The same fault occurred 4 times during the flight.

Figure 35: Electronic Module of RTLUs
