Technical document

Spectral analysis of ATC communications

Document reference: BEA_sp-I120501_tec01

Aircraft type: Liberty XL2 Registration: SP-AXL

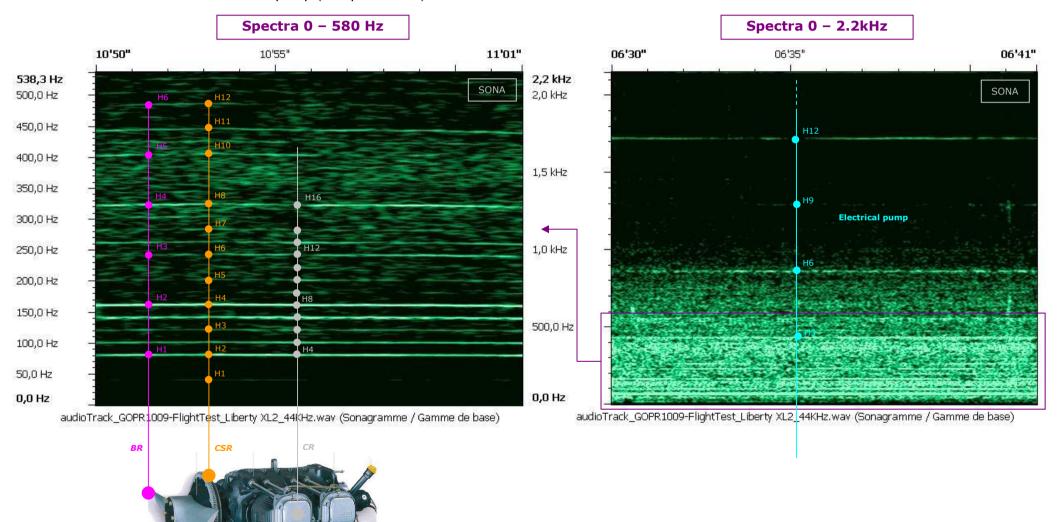
Appendix 1 - Liberty XL 2 flight test - Video / soundtrack Liberty XL2 acoustic signature

There were two main frequency bandwidths useful to display the spectral components of the XL2 propulsion system:

- 0 to 500 Hz for the propeller and engine
- 0 to 2200 Hz for an electrical pump (non-permanent)

The audio track of the video file was analysed to determine the acoustic signature of the propulsion system (engine and propeller) recorded in the cockpit during the Liberty XL2 flight test. The frequencies associated with the propeller, engine and pump were present in the spectra and were used as a reference for the analysis of the recordings related to the event flight (see appendix 1).
