FINAL
KNKT.14.12.29.04

Aircraft Accident Investigation Report

PT. Indonesia Air Asia
Airbus A320-216; PK-AXC
Karimata Strait
Coordinate 3°37'19"S - 109°42'41"E
Republic of Indonesia
28 December 2014

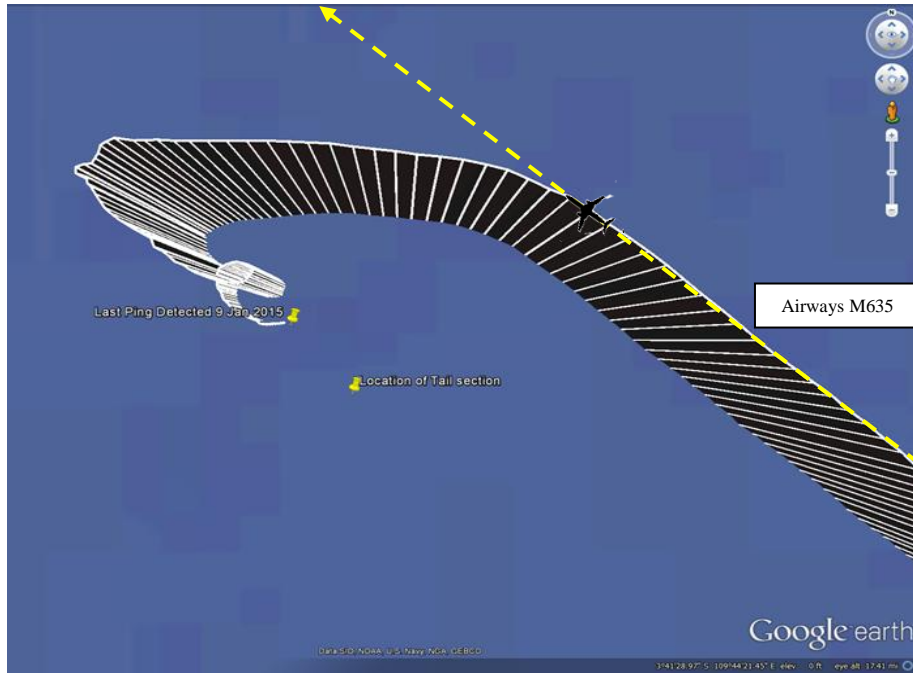
Figure 19: Flight path based on FDR data superimposed to the Google Earth

The FDR data showed that while the aircraft was cruising at an altitude of 32,000 feet in normal condition, the aircraft then deviated to the left from airway M635. The master caution triggered by both RTLU problems activated 4 times. The fifth master caution was related to the FAC 1 FAULT activating. The sixth master caution was triggered by the FAC 1+2 FAULT and followed by the autopilot and auto-thrust disengaged and flight control law reverted from Normal Law to Alternate Law.

Subsequently the aircraft entered a steep turn and climb, eventually reaching high angle of attack, the stall warning activated and continued until the end of the recording. The FDR and CVR recording ended at 2320:35 UTC.

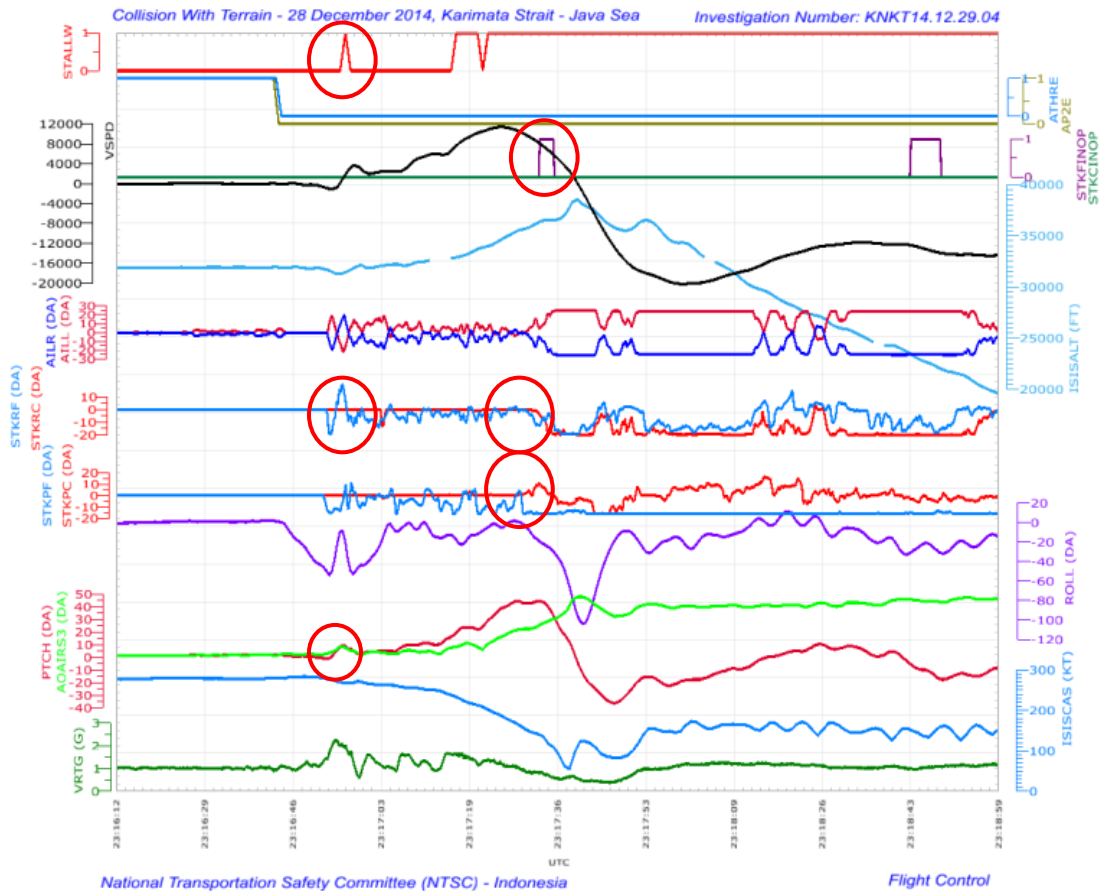
Figure 22: Pilots inputs on side stick

- o Flight control law reverted from Normal Law to Alternate Law
 - o Rudder deflected 2° and aileron deflection 0°.
- The aircraft started to roll.
- At 2316:54 UTC the FAC 2 was back to ON and all fluctuating parameters stopped. The autopilot and auto thrust remained disengaged. Flight control law remained in Alternate Law.

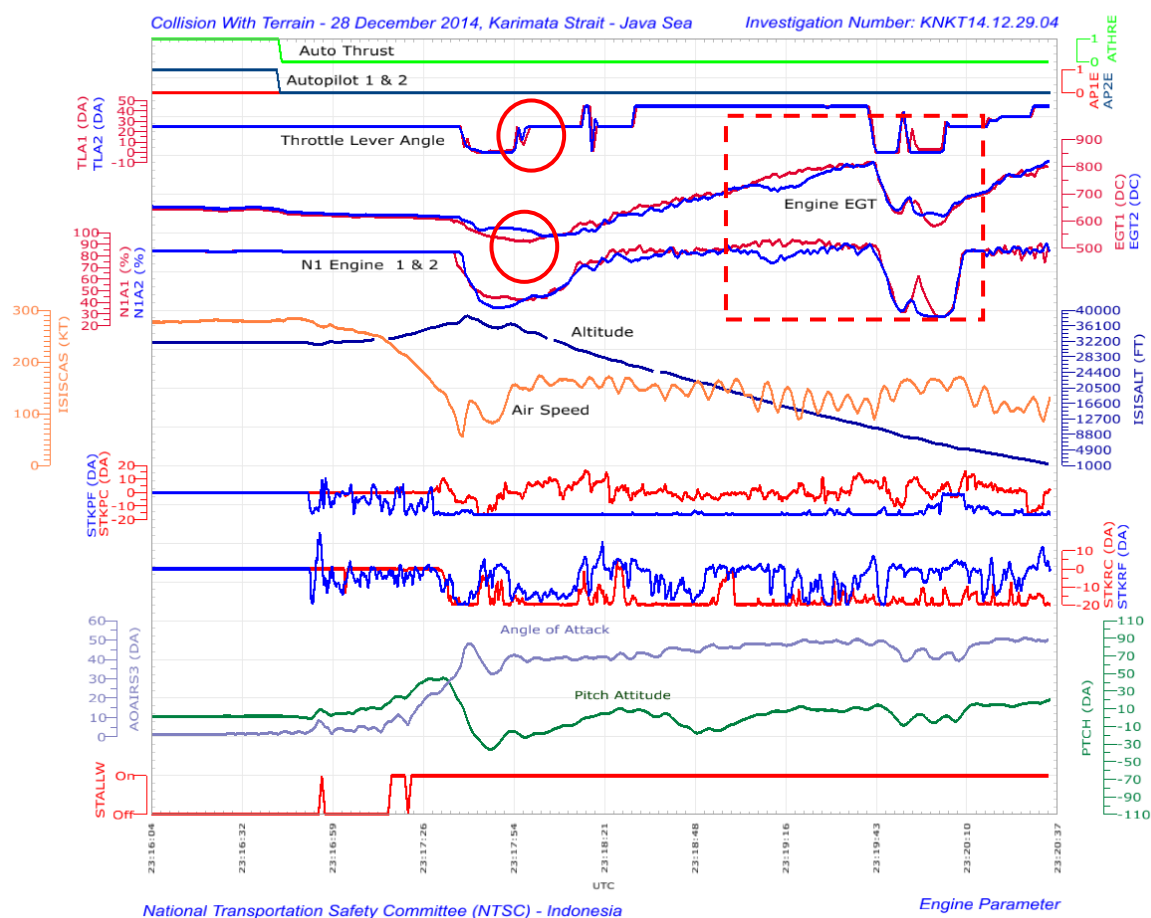
Figure 23: Thrust levers and side-sticks movement

- At 2317:41 UTC the aircraft reached the highest altitude of 38,500 feet (ISIS) and largest roll angle at 104° to the left. The aircraft then descended with a rate up to 20,000 feet per minute momentarily afterward the rate of descent was recorded at average of 12,000 feet per minute until the end of recording.

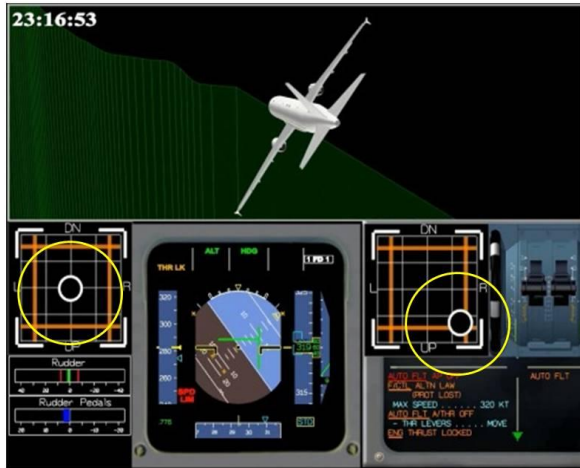
Figure 25: Aircraft rolled 54° to the left

Speed (knots)	277 (ISIS)	282 (CAS)
Alt (feet)	31952	
Rudder	2°	
Roll	54°	
Pitch	-1.1°	
AOA	3.5°	
VS(fpm)	-1088	
N1	83%	
EGT	622 °C	
Sidesticks	PIC P: 0° R: 0°	SIC P: -15° R: +19

Time (UTC)	From	To	Description
23:16:43	Warning		Auto pilot disengaged followed by cavalry charge (autopilot disengaged warning)
23:16:53	P1		“Oh my God”
23:16:54			The FAC 2 was re-energized
23:16:56	Warning		Stall warning activated for 1 second

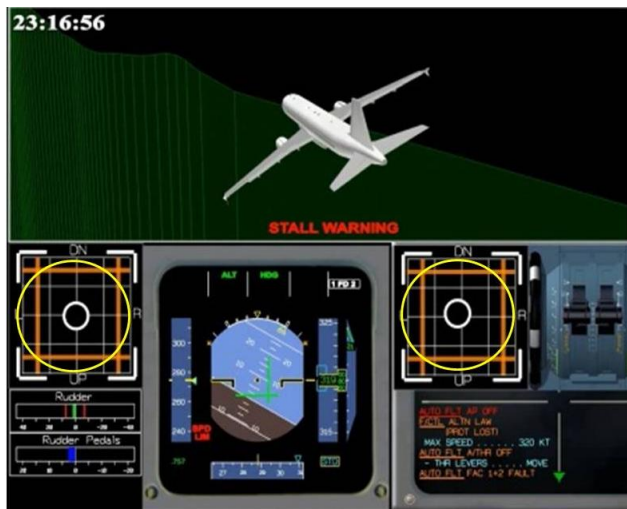
Figure 26: The first aural Stall warning activated

Speed (Knots)	268 (ISIS)	272 (CAS)
Altitude (Feet)	31980 (ISIS)	33900 (GPS)
Rudder	2°	
Roll	19.7°	
Pitch	9.5°	
AOA	8°	
VS (fpm)	2624	
N1	83%	
EGT	621 °C	
Side-sticks	PIC P: 0° R: 0°	SIC P: 7° R: +10°

Time (UTC)	From	To	Description
2317:02	P1		Gave instruction “level...level...level...” (4 times)
2317:15	P1		Gave instruction “pull down...pull down” (2 times)

2317:17	Warning		Aural stall warning announced with cricket sound. Change of external airflow sound.
2317:22	P1	P2	Gave instruction “pull down...pull down” (3 times)

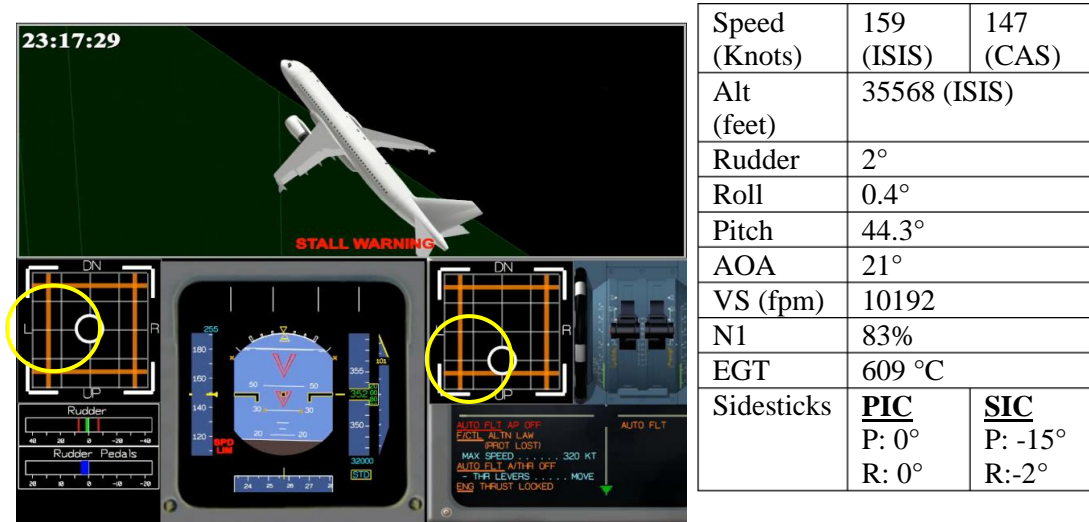
Figure 27: The aircraft attitude at the highest pitch angle

Time (UTC)	From	To	Description
2317:23	Warning		Aural stall warning activated with cricket sound and a sound similar to aircraft buffet continued until the end of recording.
2317:25	P1		Gave instruction “pull down...pull down”
2317:29	P2		<i>in French</i> : “What is going wrong”
			The left side stick input continued until the end of recording. Dual input on the side sticks continued until the end of recording.

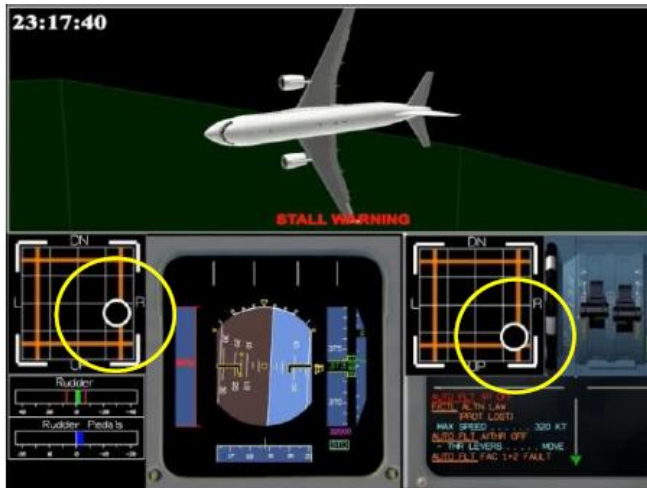
Figure 28: Aircraft in upset¹³situation

Speed (knots)	118 (ISIS)	0 (CAS)
Alt (Feet)	37796 (ISIS)	
Rudder	-5°	
Roll	-104 °	
Pitch	-20.7°	
AOA	46°	
VS (fpm)	-4784	
N1	52%	
EGT	563 °C	
Sidesticks	PIC P: -4° R: -20°	SIC P: -16° R: -17°

Time (UTC)	From	To	Description
2317:41	P1		“My God.”

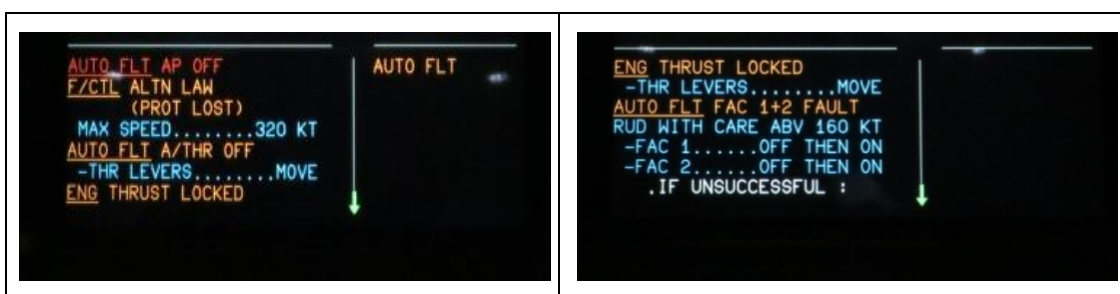
Figure 33: The page 1 and 2 of the ECAM messages after CBs of FAC 1 and 2 being reset

- Similar ECAM messages to the data recorded on the FDR appeared when the FAC CBs were pulled.
- Dual input resulted in rapid movement of the aircraft compared to single input
- Dual input in different direction of the side-sticks reduced the ability to control the aircraft.
- The Emergency Cancel Button was effective to prevent pilot distraction for a repetitive malfunction.

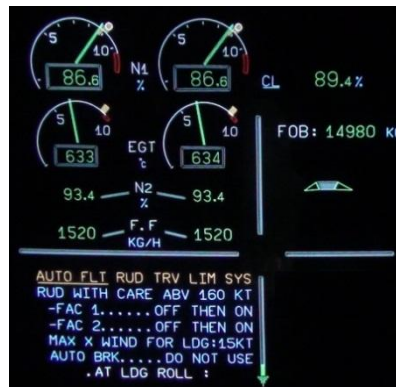
Figure 34: The ECAM messages after RTLTLU 1 and 2 fault

As requested by the KNKT, BEA and Airbus performed the simulator session which referred to FDR data on the engineering simulator. The simulation intended to recreate ECAM messages appeared on the accident flight. The ECAM message during the RUD TRIM LIM SYS problem is presented in the following figure:
